STAFF RECOMMENDATION

SUBJECT: Evaluation of Significance to Rockville of 19 and 20 West Montgomery Avenue

DESCRIPTION: Rockville Town Center, Block 4 Subdivision Lot P21

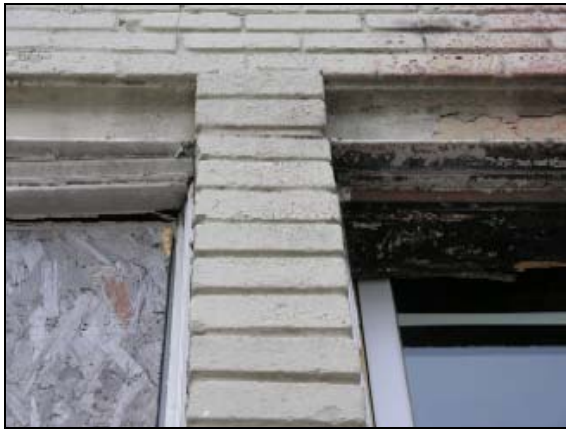
18 West Montgomery Avenue, façade detail

The east bay of the façade is characterized by tripartite fenestration (-w-d-w-) topped by three transoms. The central double door is a recent replacement. The brick piers that separate the windows and door openings are stacked stretcher bricks that do not follow the overall course pattern of the brick façade. These piers may be only facing material. A metal I-beam is the lintel of the openings. The windows have stone sills and the door threshold is stone.

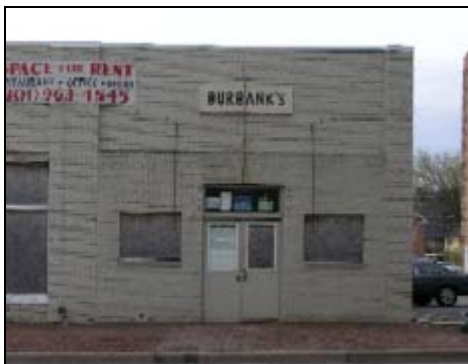
West bay of facade

The West Bay of the façade is characterized by a two-thirds height brick infill that builds out the façade so that it is flush with the piers. Bricks used for this infill wall are more textured than the other façade bricks. An additional brick type was used to patch previous window openings on the west façade bay. The top or cornice line of the infill consists of a brick header row. The only transom is above the door and it is ½ the height of the east bay transoms. The west bay window openings are approximately half the size of the east bay windows. These windows are boarded over, but their slightly projecting brick header sills are evident. The painted metal double doors appear to be recent retail stock items. The brick wall above the infill contains numerous pieces of hardware that likely supported a variety of different signs.

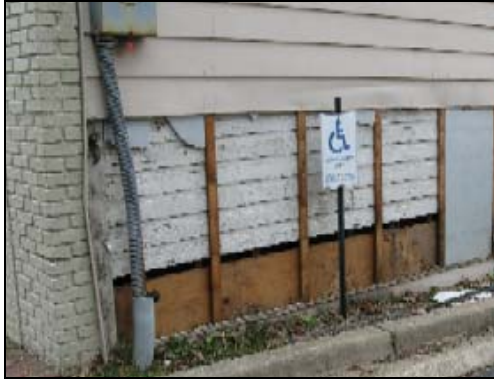
West elevation with German Siding,
November 2007

The west elevation of the building is completely covered with recent vinyl siding. A photograph taken before the repair of the west elevation's vinyl siding indicates wood German siding underneath. The east elevation is faced with stucco. The three vinyl windows have been recently installed and are trimmed with wide painted wood surrounds.

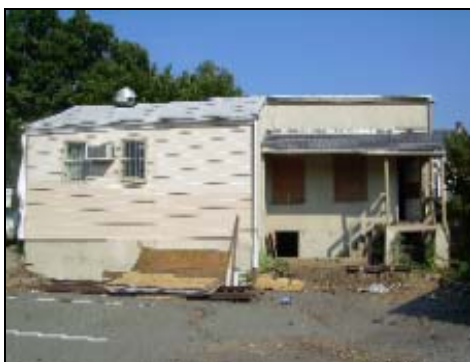
Rear elevation, November 2007

The rear of the east bay has recently been altered by an incomplete construction project. The east half of the rear elevation is recessed from the west rear addition. Two 1/1-sash windows and a rear door pierce the wall. The pre-construction photo on the left indicates the door was fronted by a stoop with side stairs supported by cement block piers. A shed roof was located above the windows about 2' below the roof and was supported by two posts on the stoop.

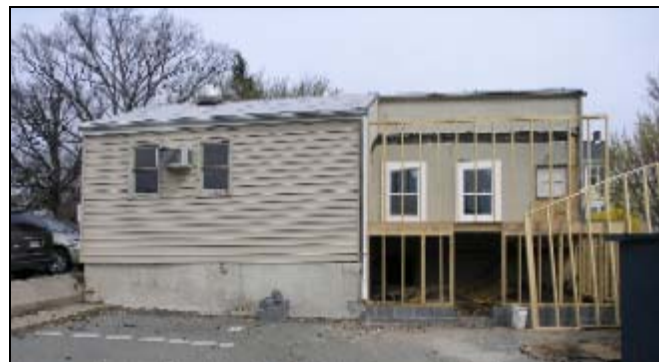
Rear elevation, current

The recent construction project has resulted in the removal of the shed roof, stairs, and stoop. A platform is built out at the door level and extends to the rear wall plane of the west bay rear elevation. A cement block foundation has been laid under the perimeter of the platform and the back wall has been framed out. The windows have been replaced with 1/1 vinyl with wide plain board surrounds, similar to those found on the east elevation.

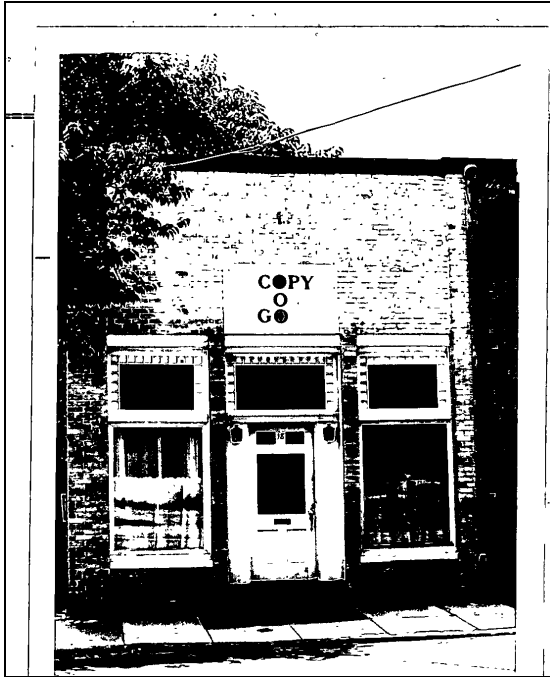
Rockville Historic Buildings and Districts Survey Form, 1976
18 West Montgomery Avenue

A 1976 City of Rockville Historic Building Inventory form contains a picture of the east bay of Burbanks, which was a "Copy to Go" store at the time. The image is from a scanned file and is not very clear. The picture shows Dentil Row moldings lining the inside of transom windows,

were probably contemporary trim applications. The eastern window appears by divided into four rectangular lights, which could have dated from the building's original construction. The top of the building has a dark band across it, which could be a former cornice element, or only paint. The small part of the west bay in the photo is much darker, suggesting the brick façade was painted two different colors.
